THE GREAT ALASKA EARTHQUAKE

Volume II

Illustrations and Maps

TECHNICAL REPORT NO. AFWL-TR-65-92, Vol II

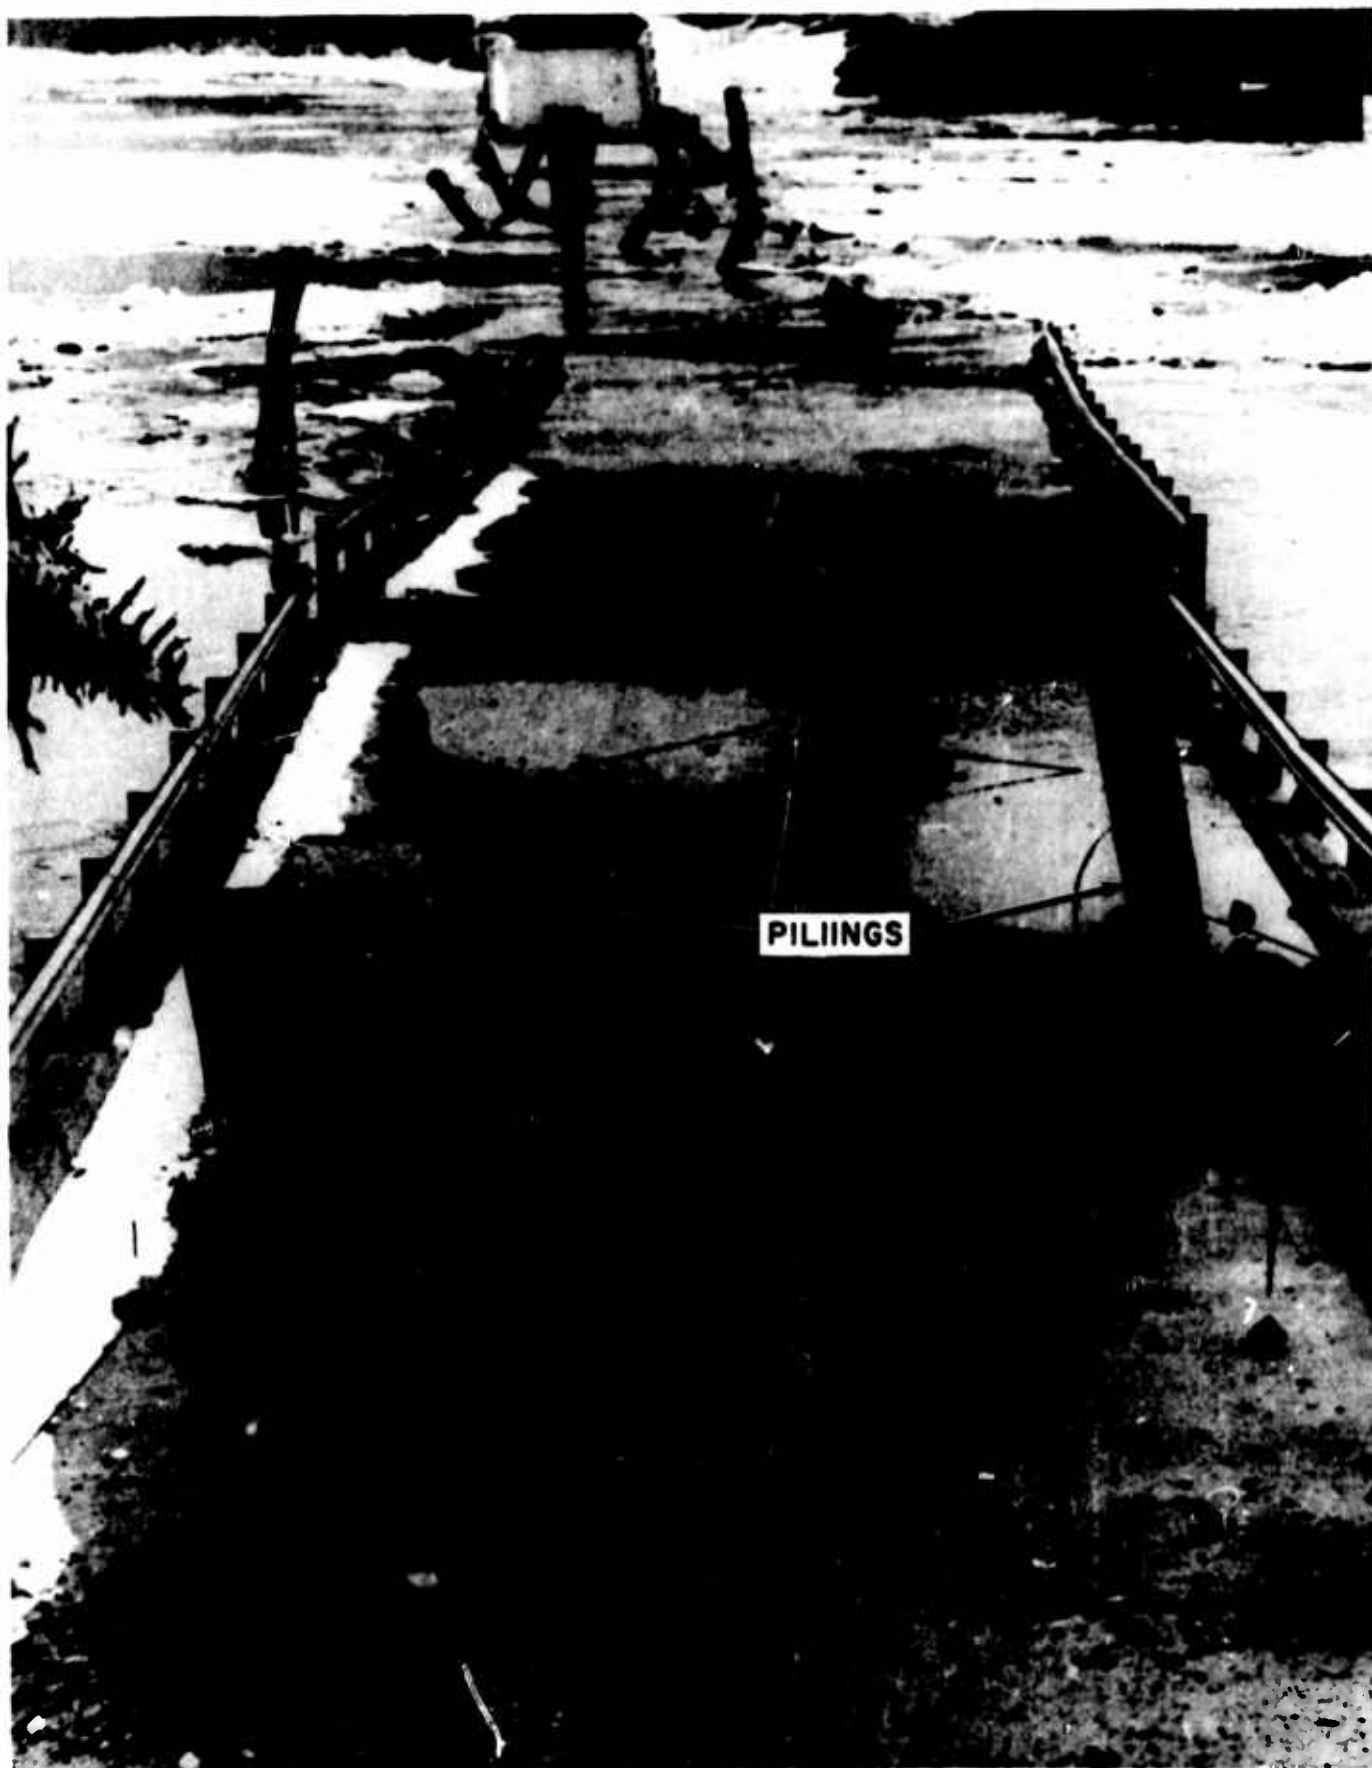
Figure 15. A Damaged Bridge, Anchorage to Seward Highway

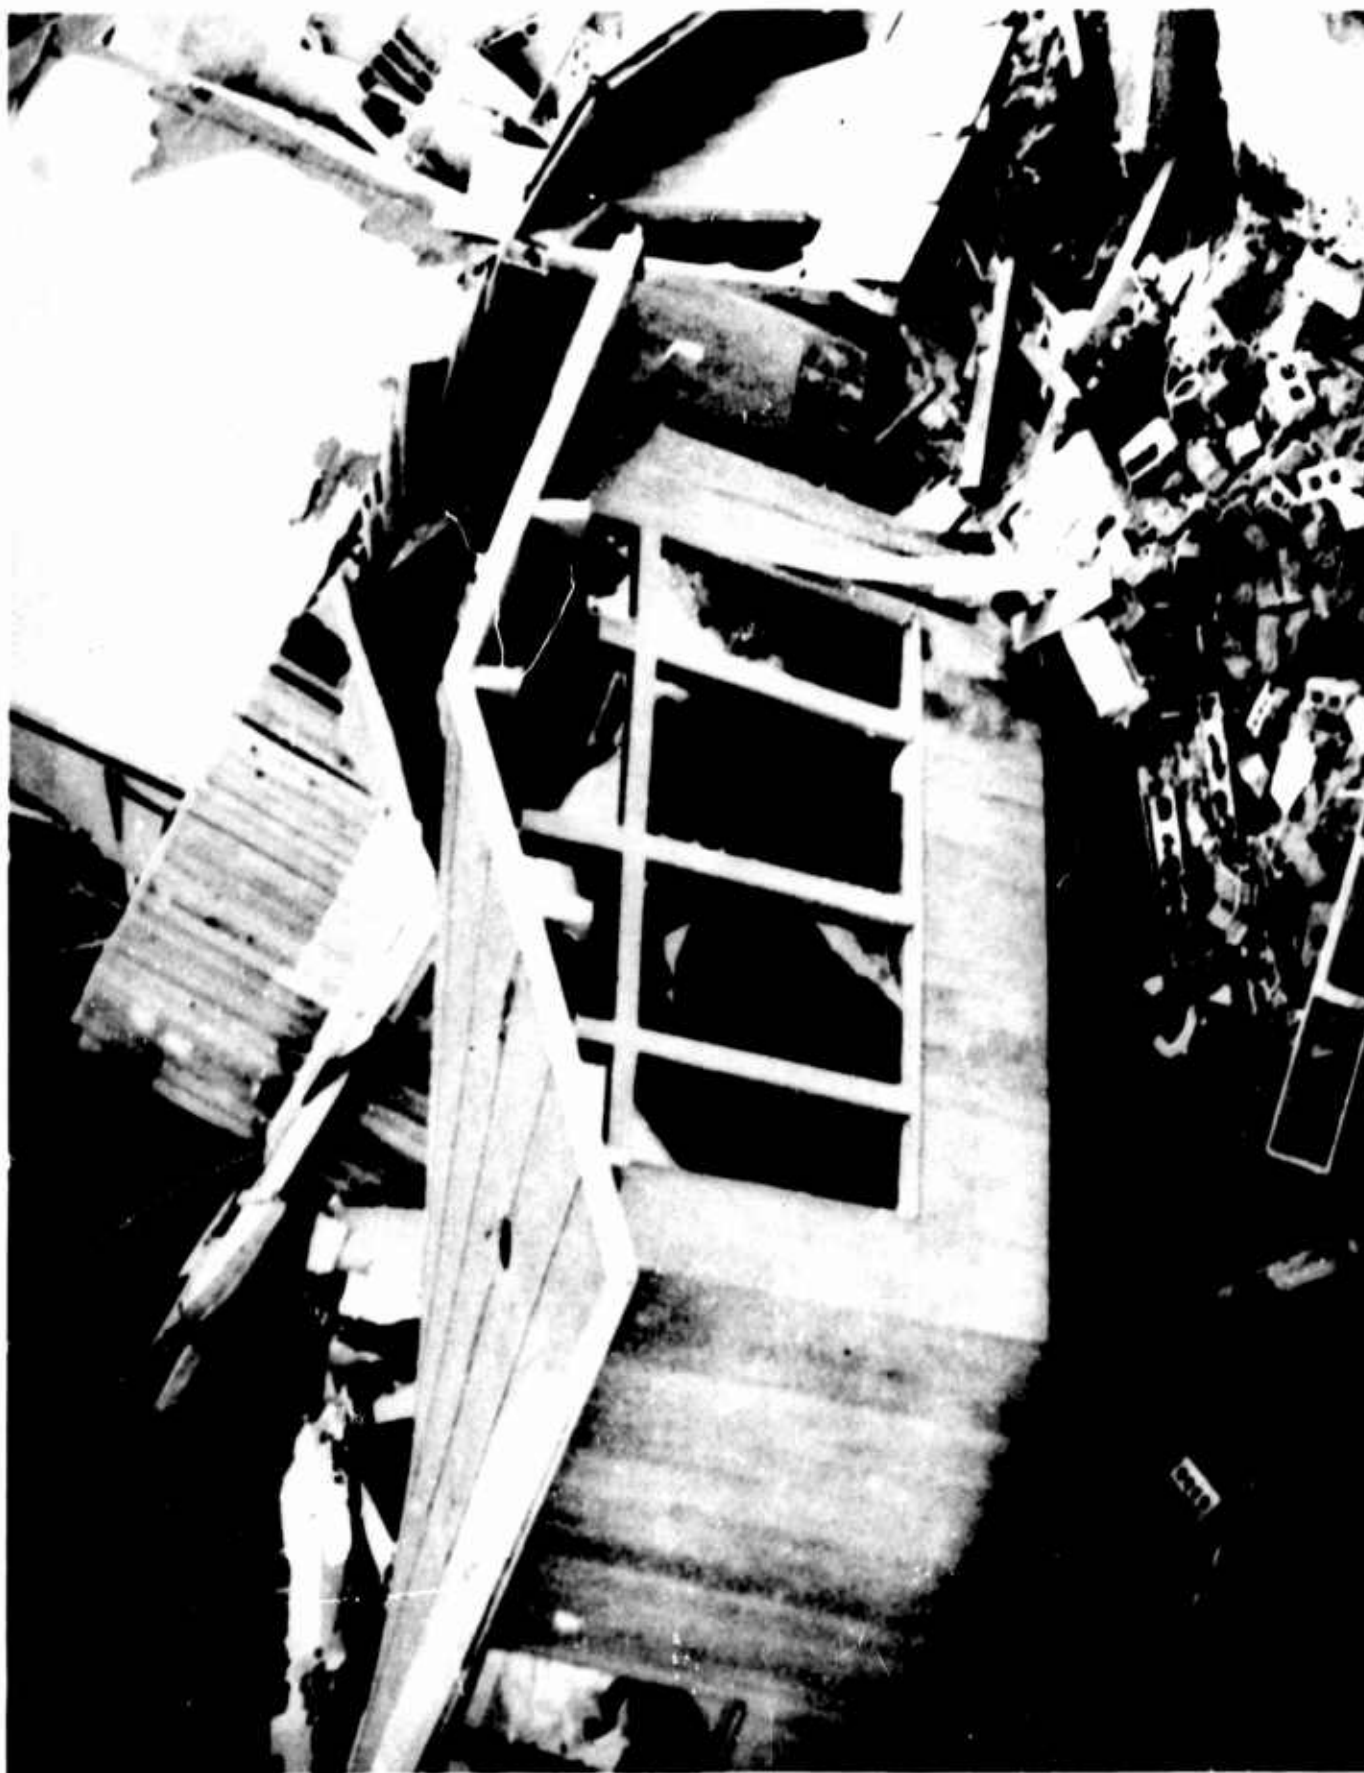
Figure 35. Turnagain Slide (Damage to residential buildings)

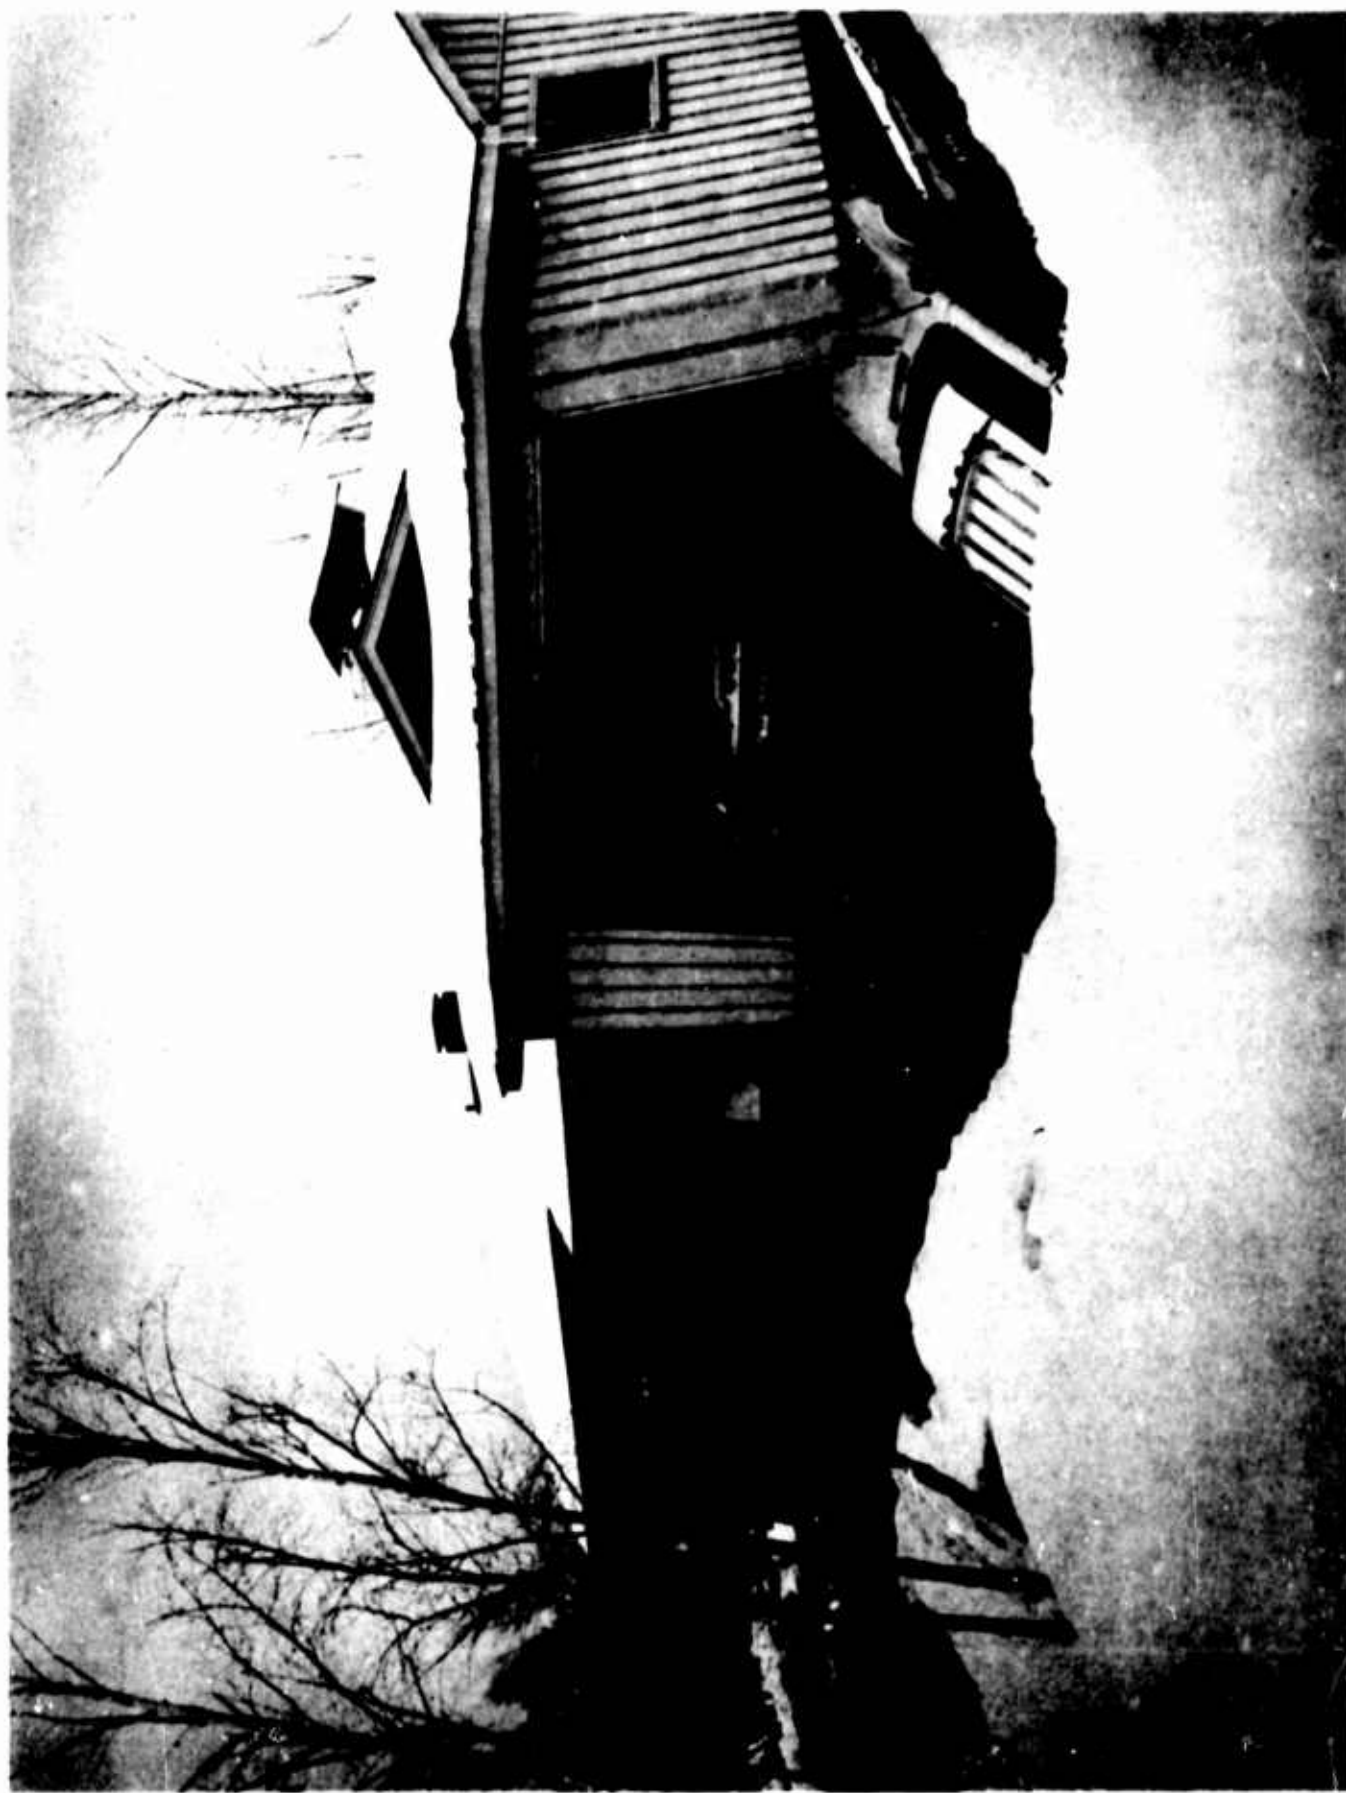
Figure 38. Turnagain Slide (Damage to residential buildings)

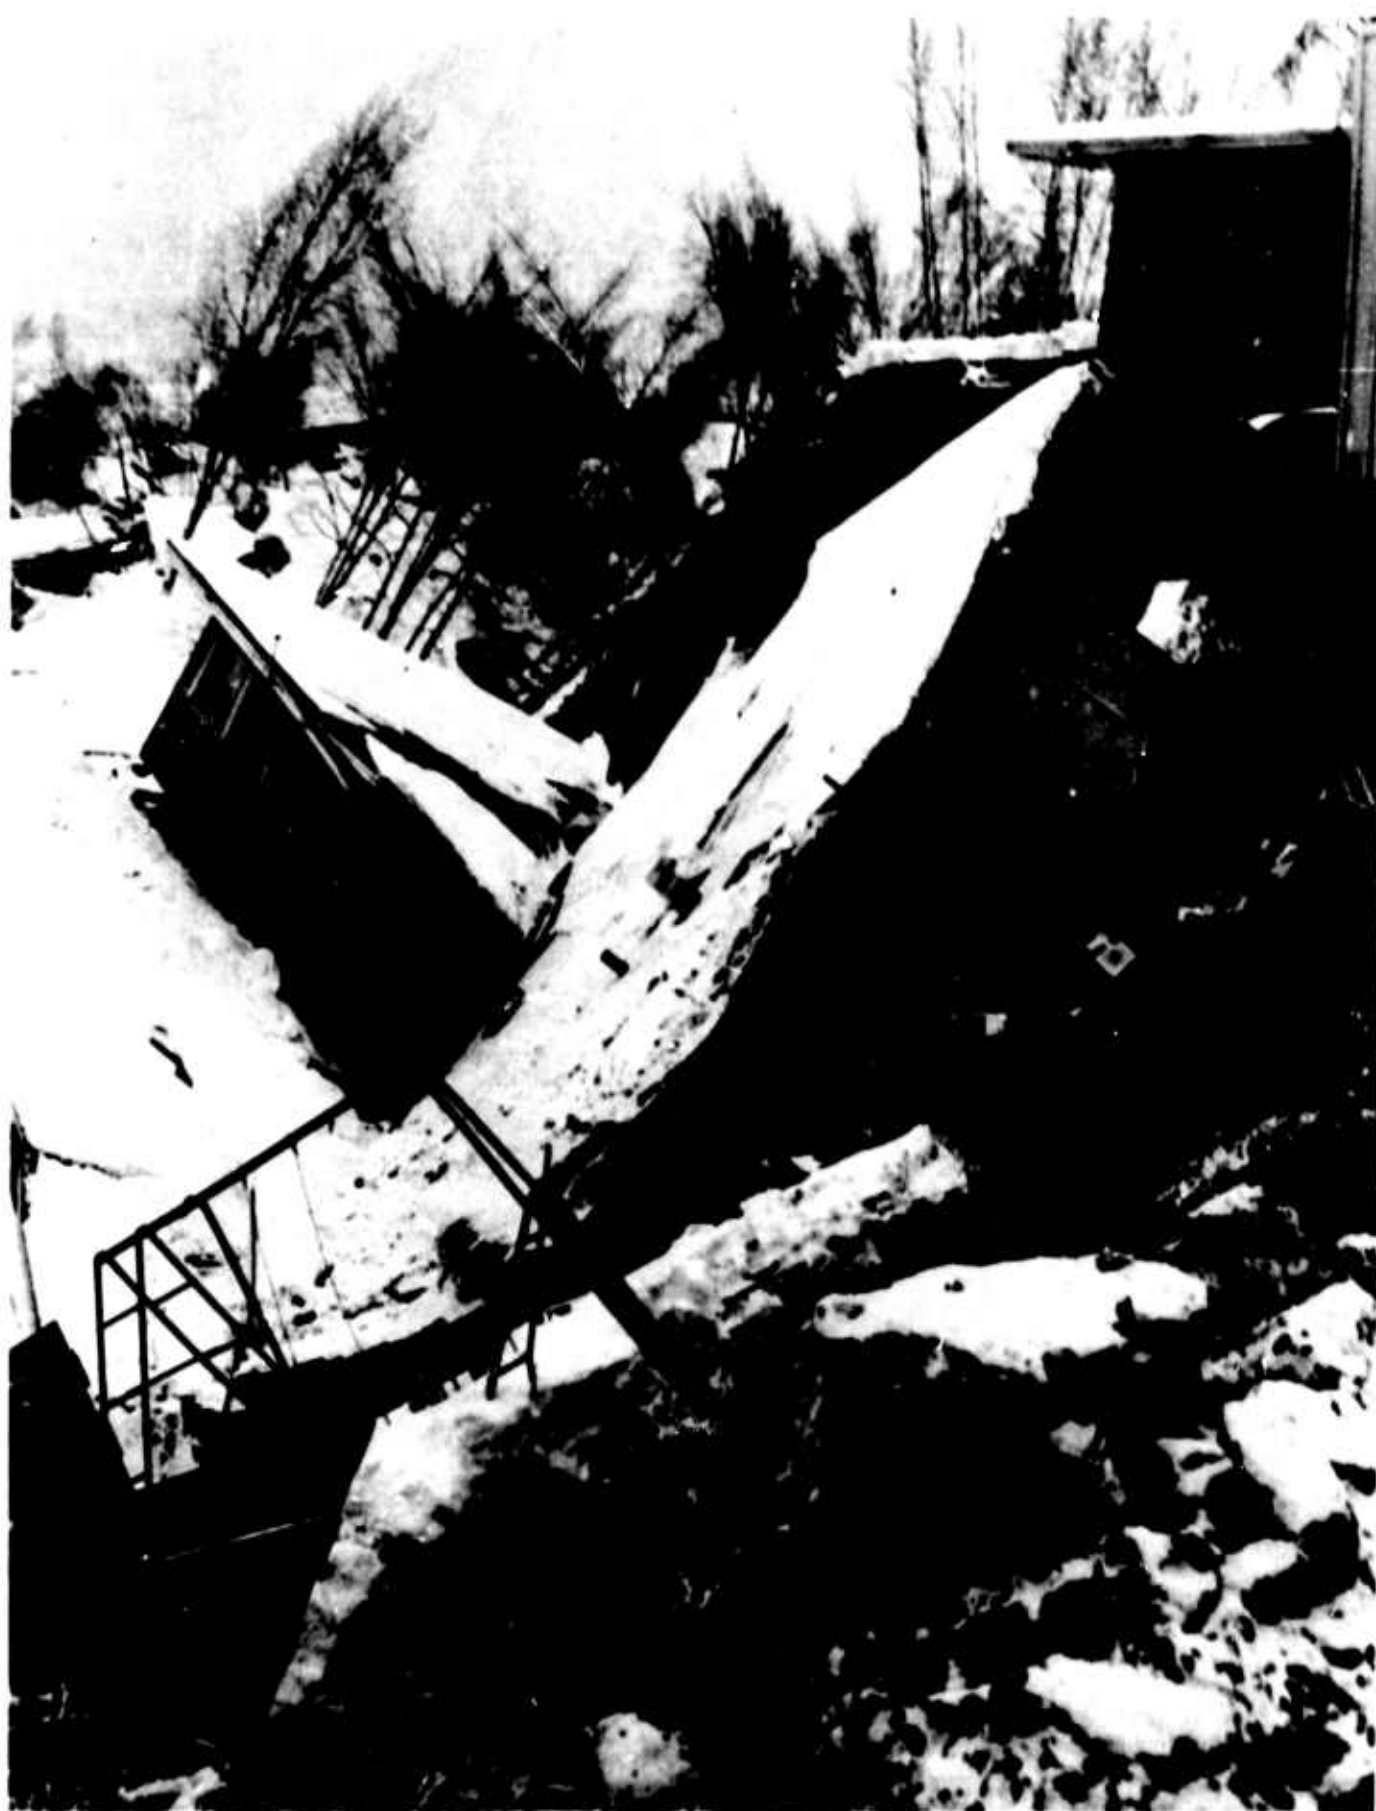
Figure 39. Turnagain Slide (Damage to residential buildings)

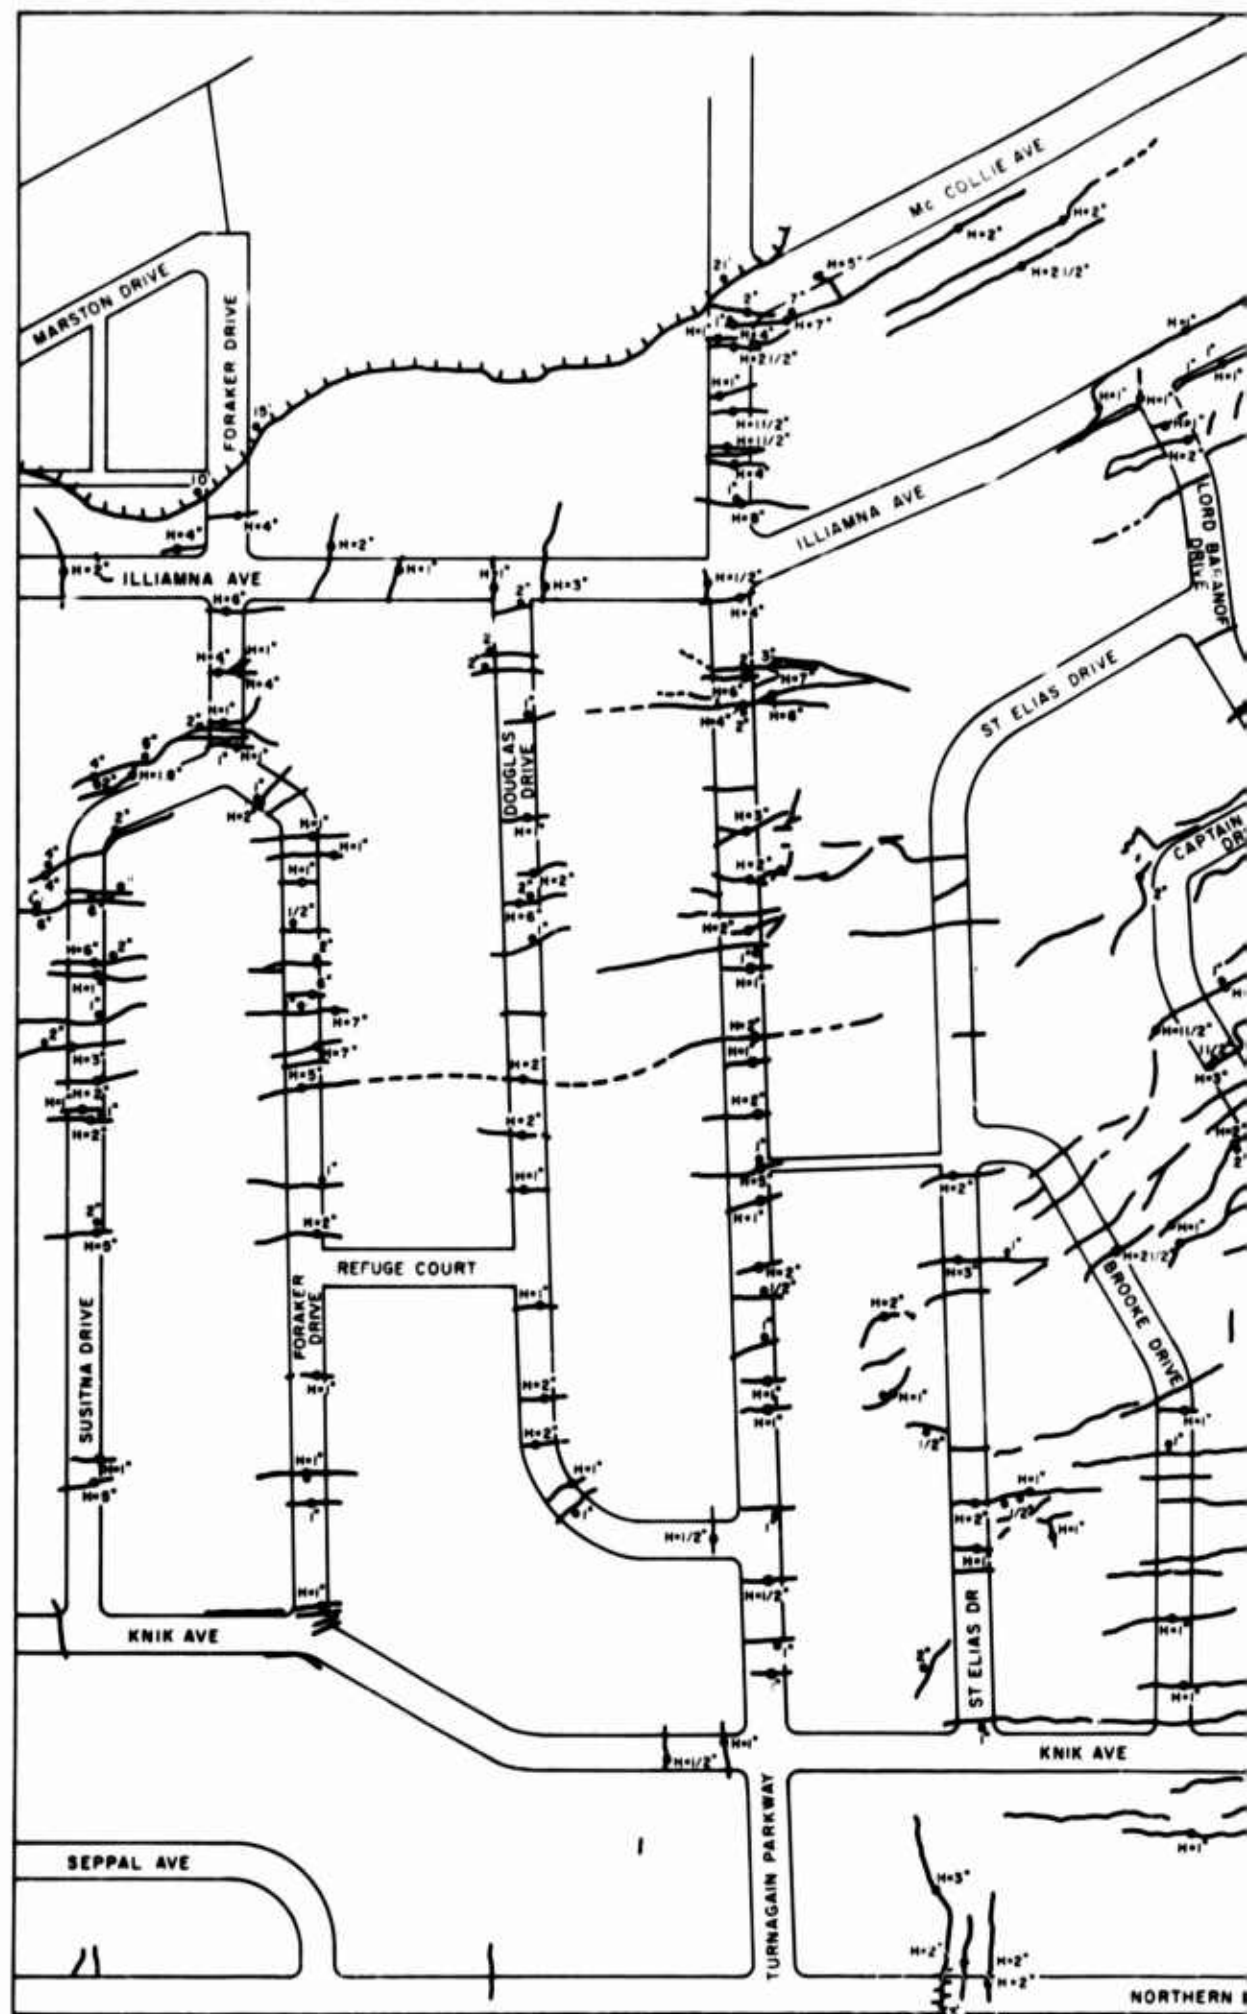
Figure 46b. Turnagain Slide (Representative fractures)
(Source: Reference VI)

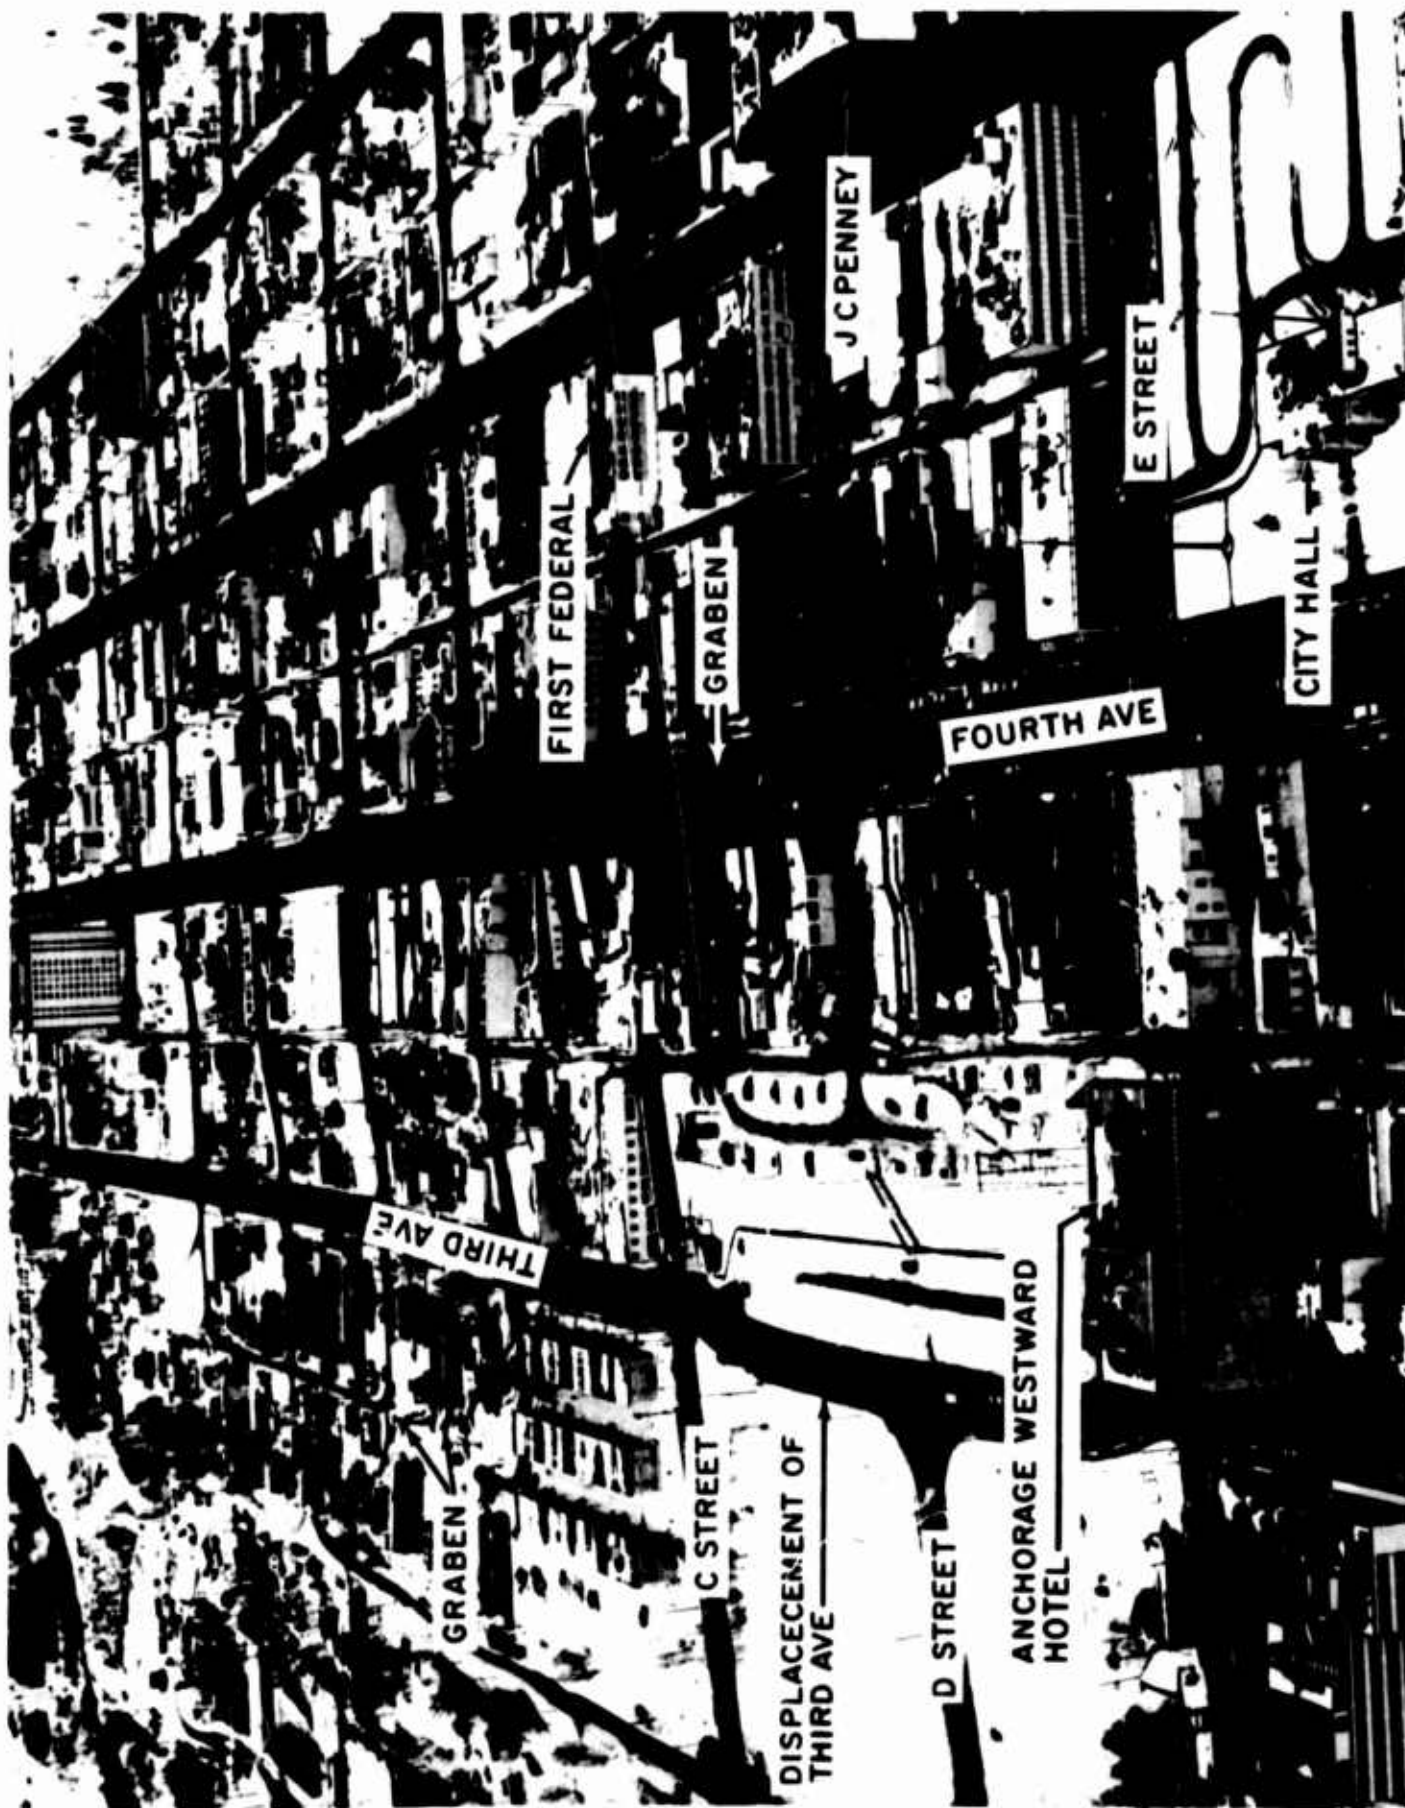
Figure 58. Fourth Avenue Slide
(Aerial view of damage to commercial buildings on the north side of Fourth Avenue)

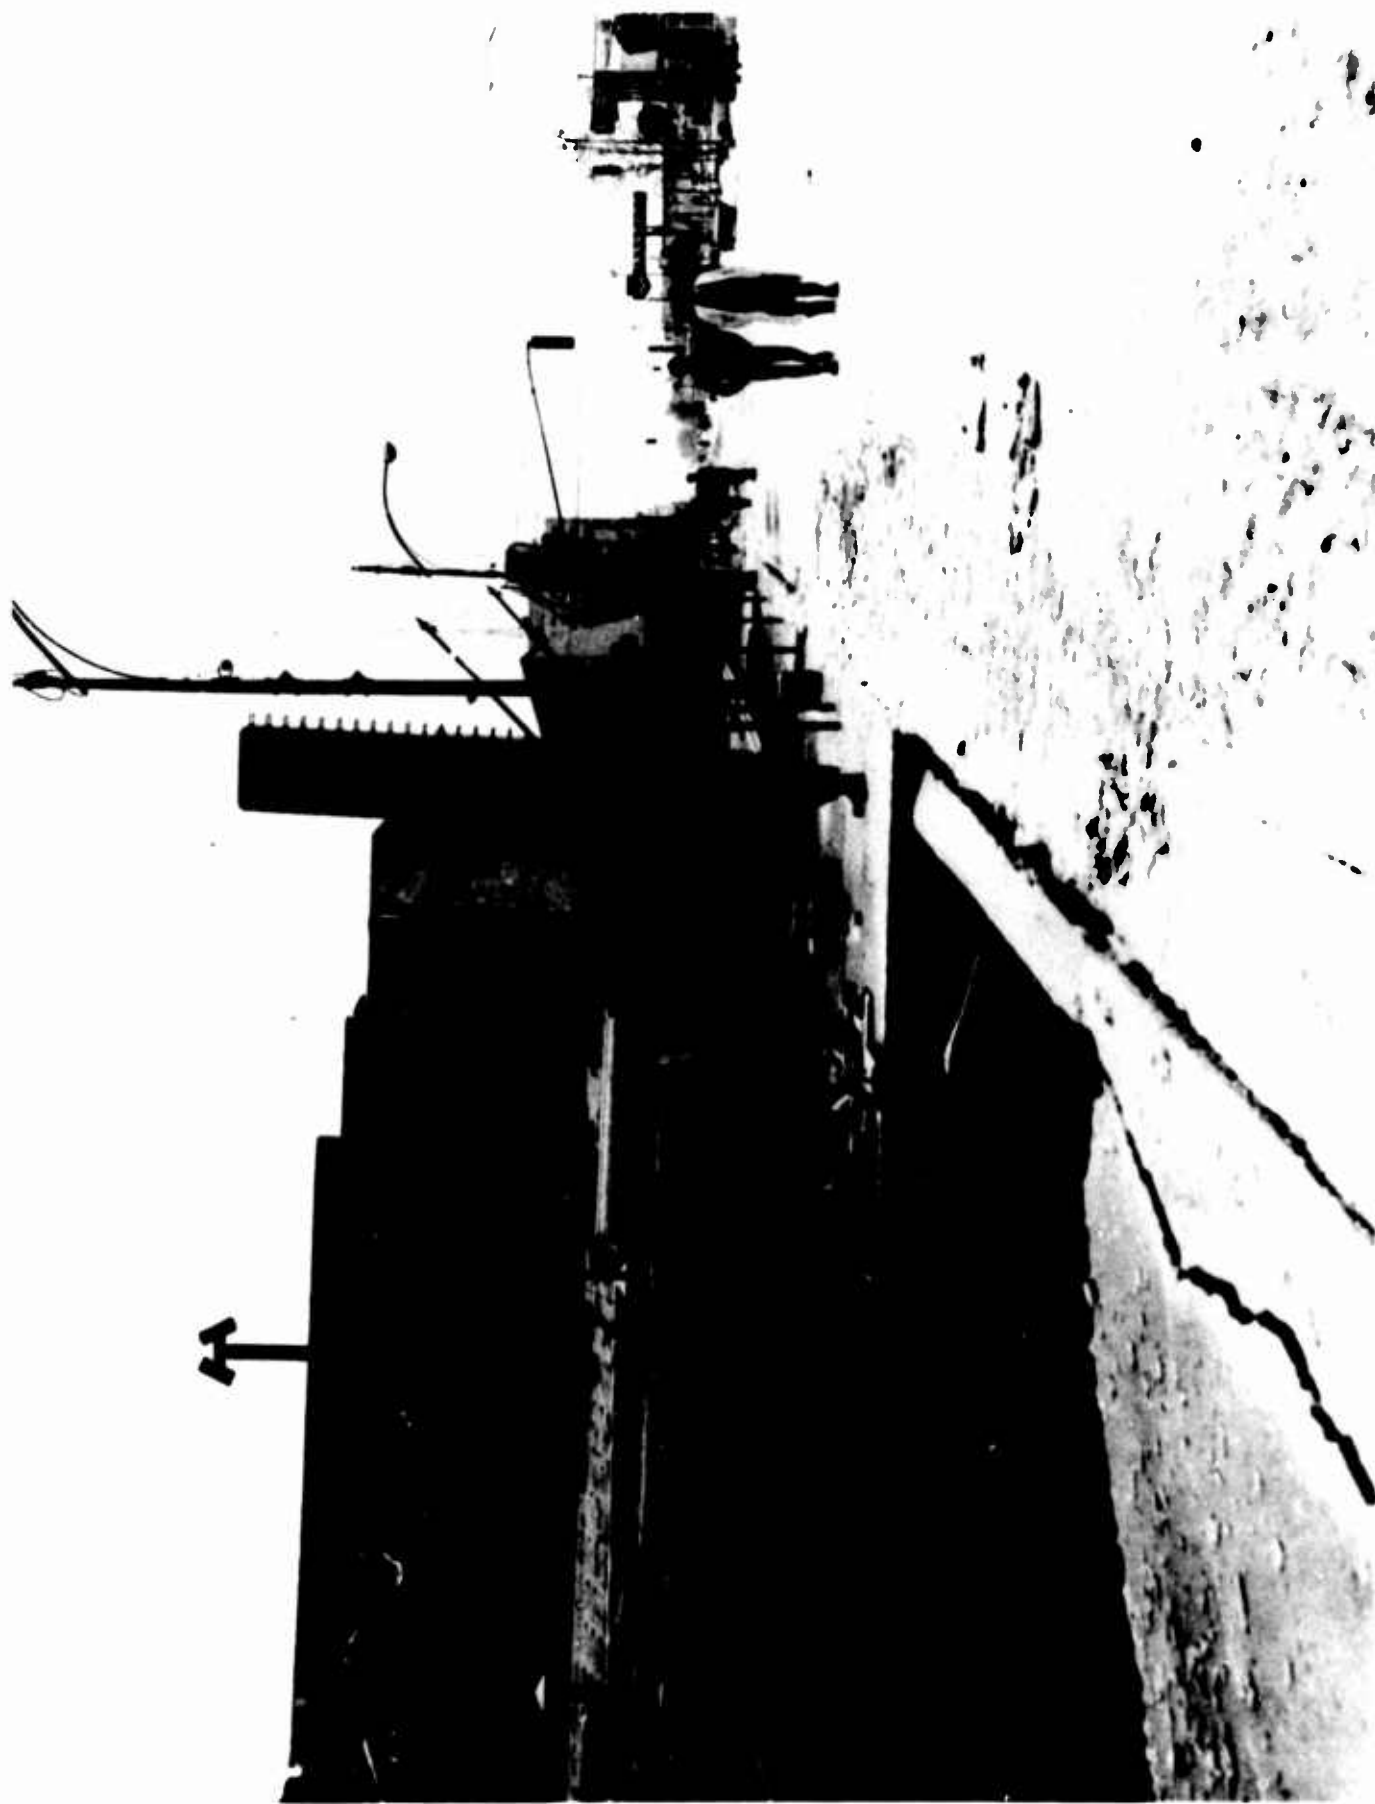
Figure 60. Fourth Avenue Slide (North side of Fourth Avenue between B and C Streets)

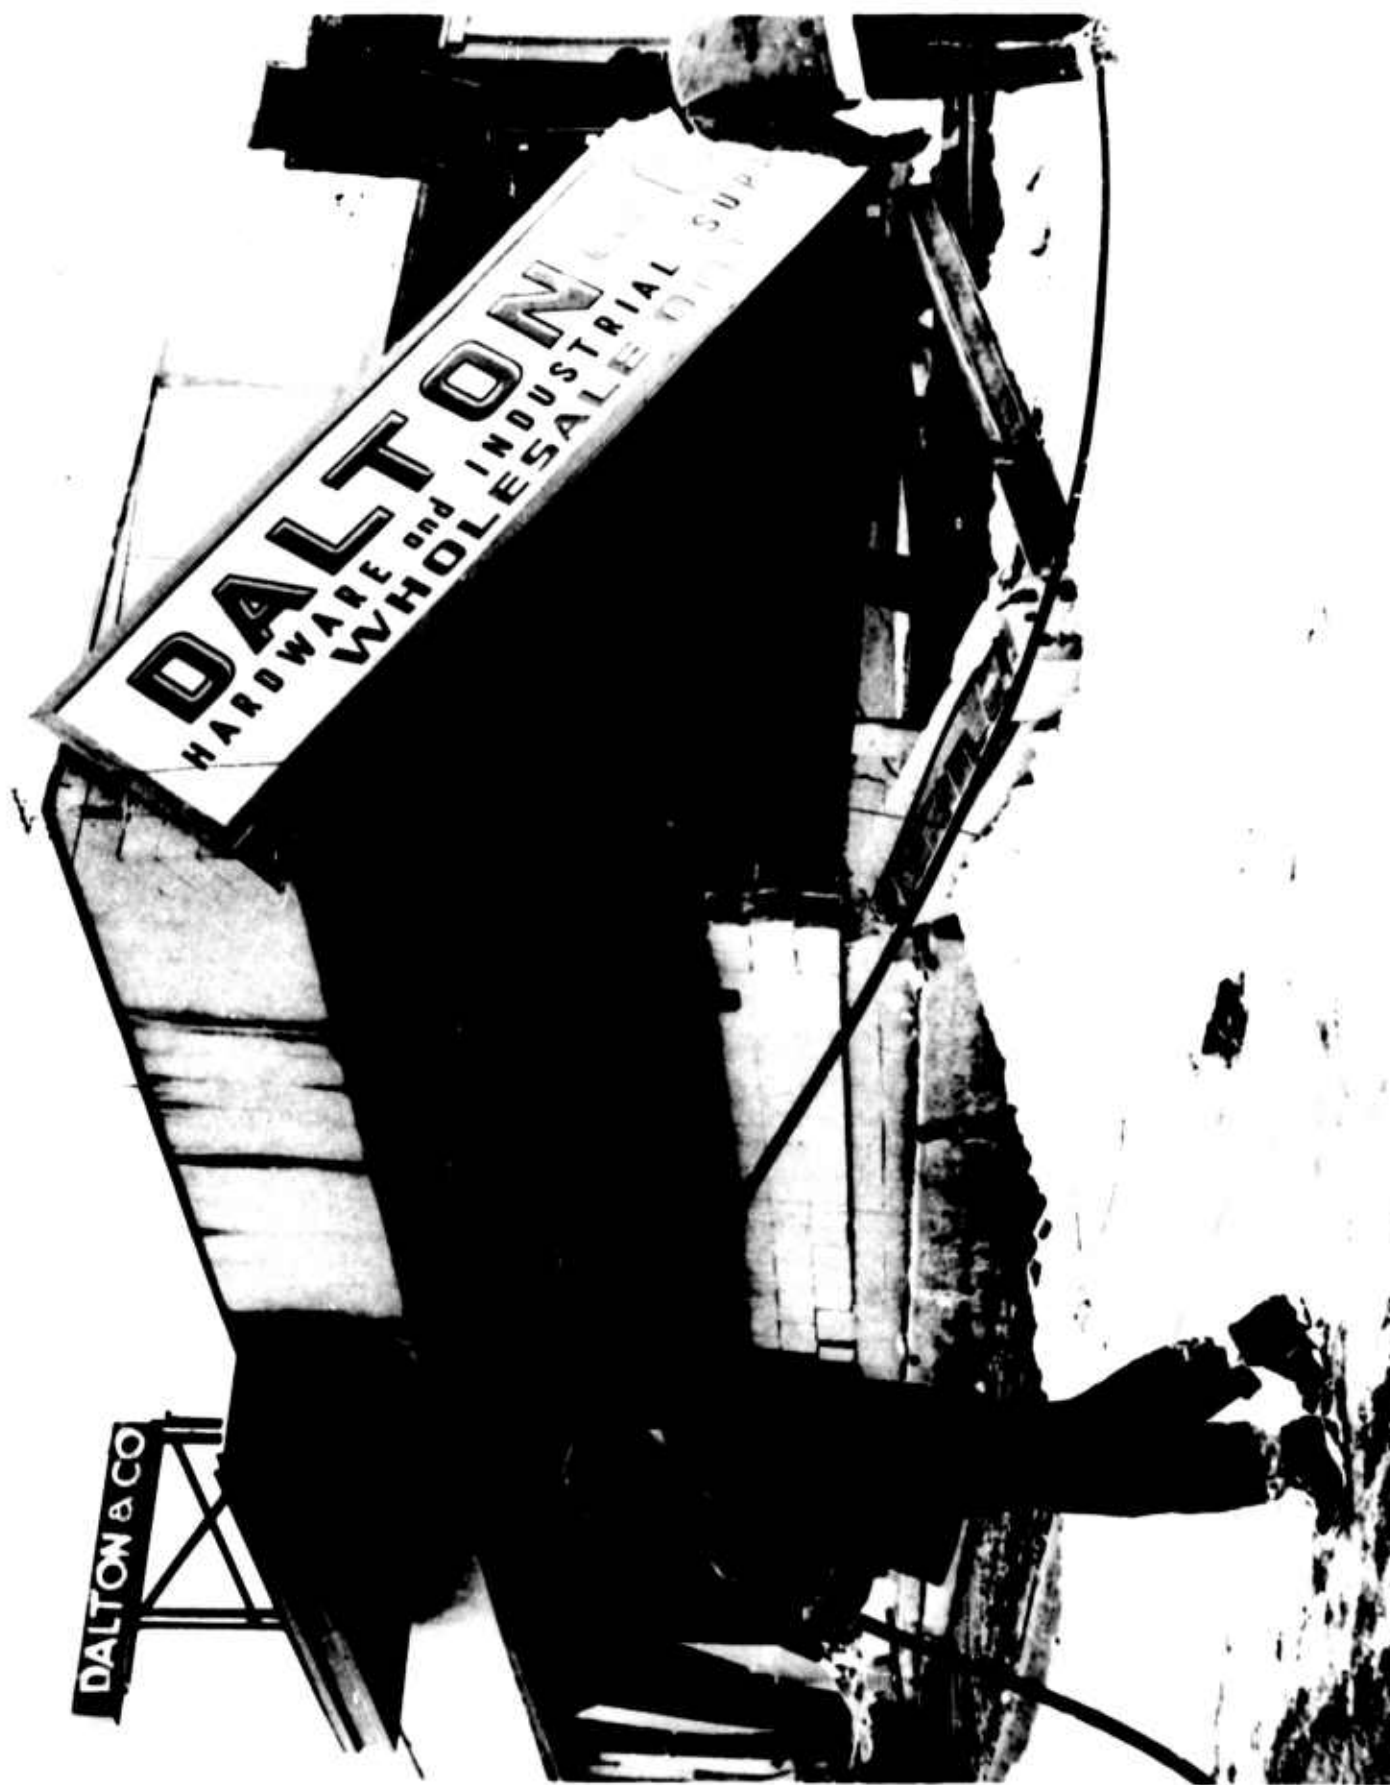
Figure 66. Fourth Avenue Slide (Dalton and Company building, destroyed by pressure ridge north of Second Street)

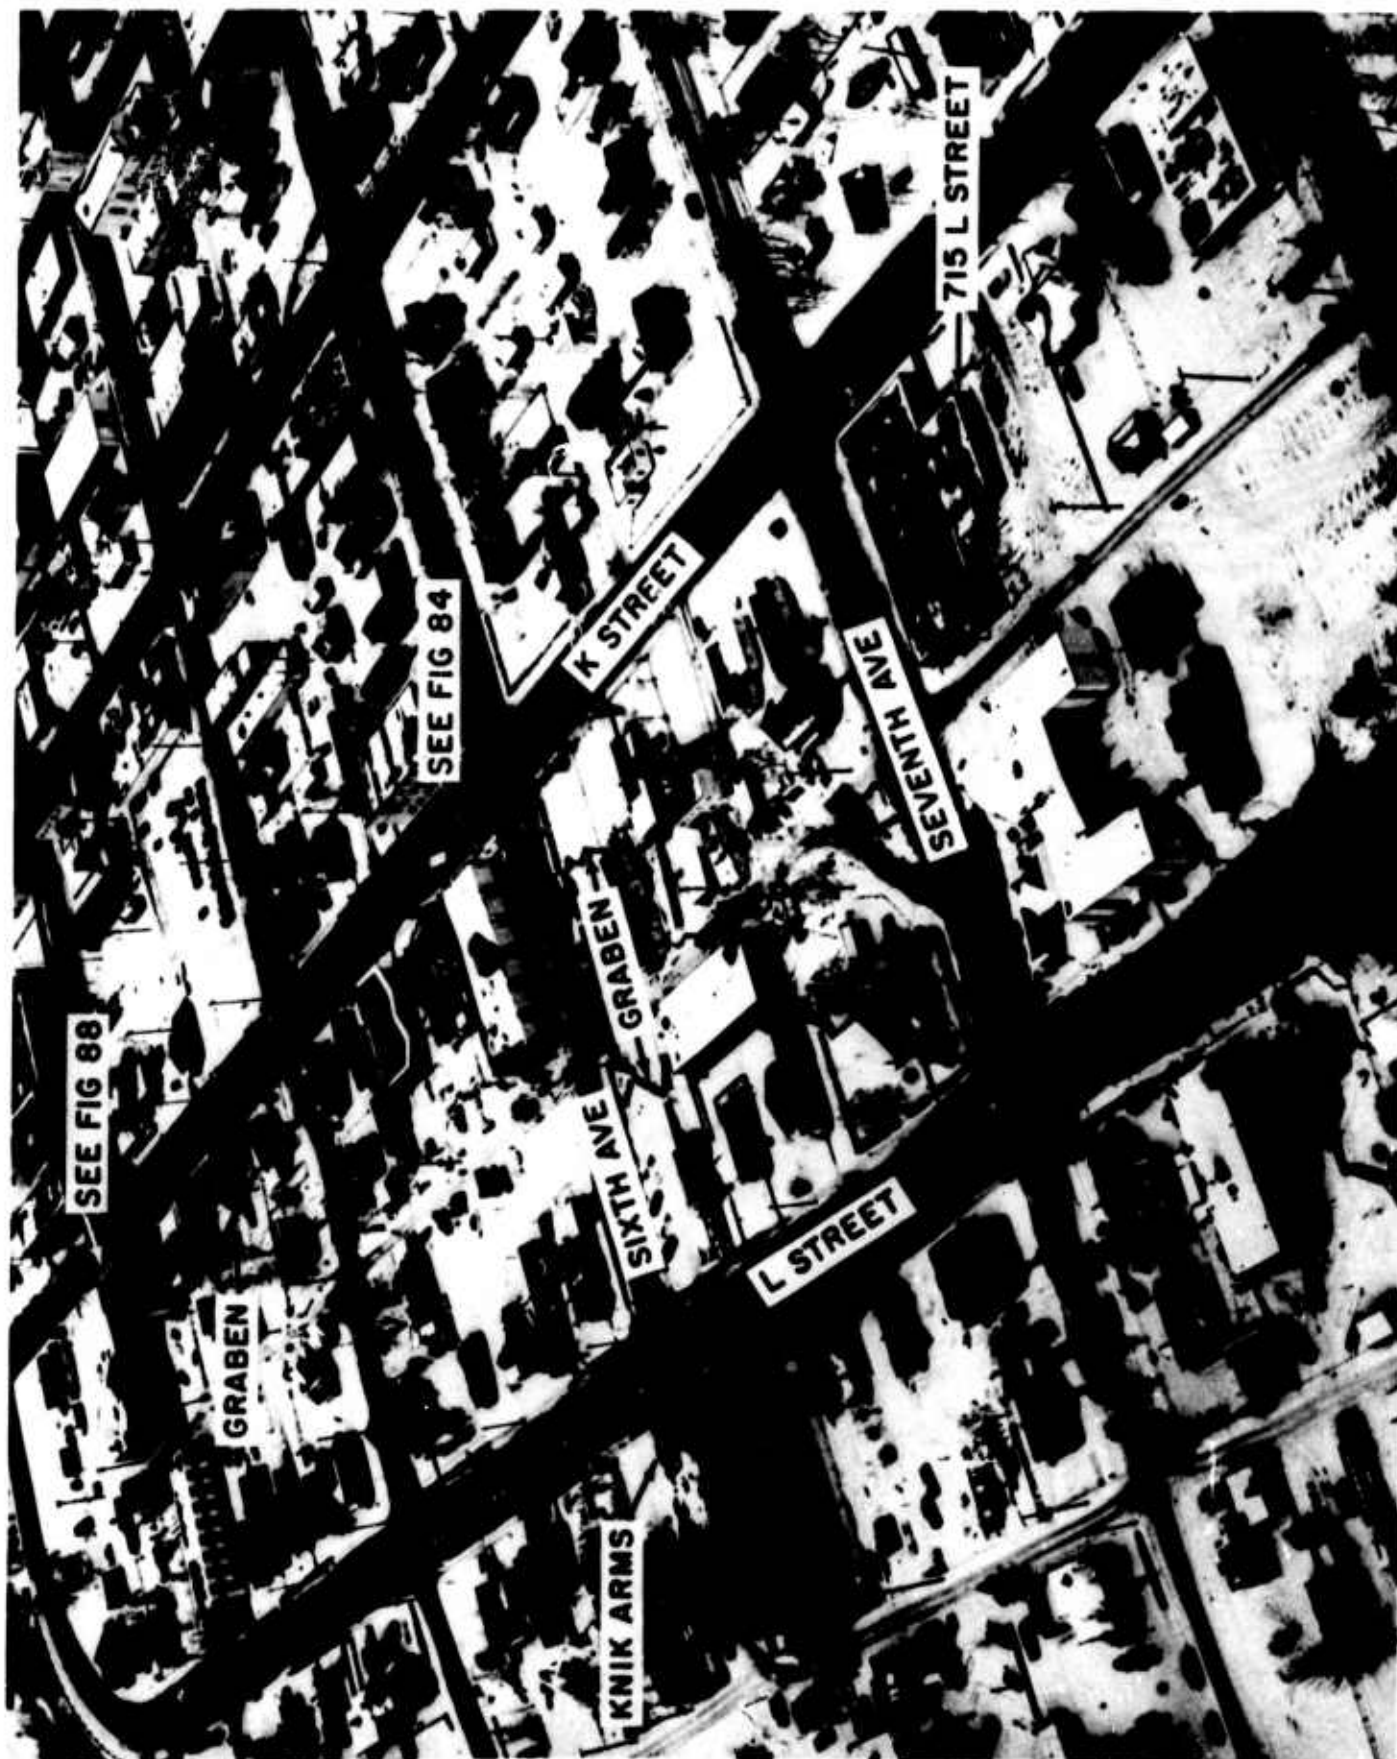
Figure 83. L Street Slide (Northern end of graben, paralleling K Street)
